FULLER'S LAKE DAM

NDI No. PA 00073
PennDER No. 58-121
Dam Owner: Frederick Hoal

PHASE I INSPECTION REPORT NATIONAL DAM INSPECTION PROGRAM

February 1981

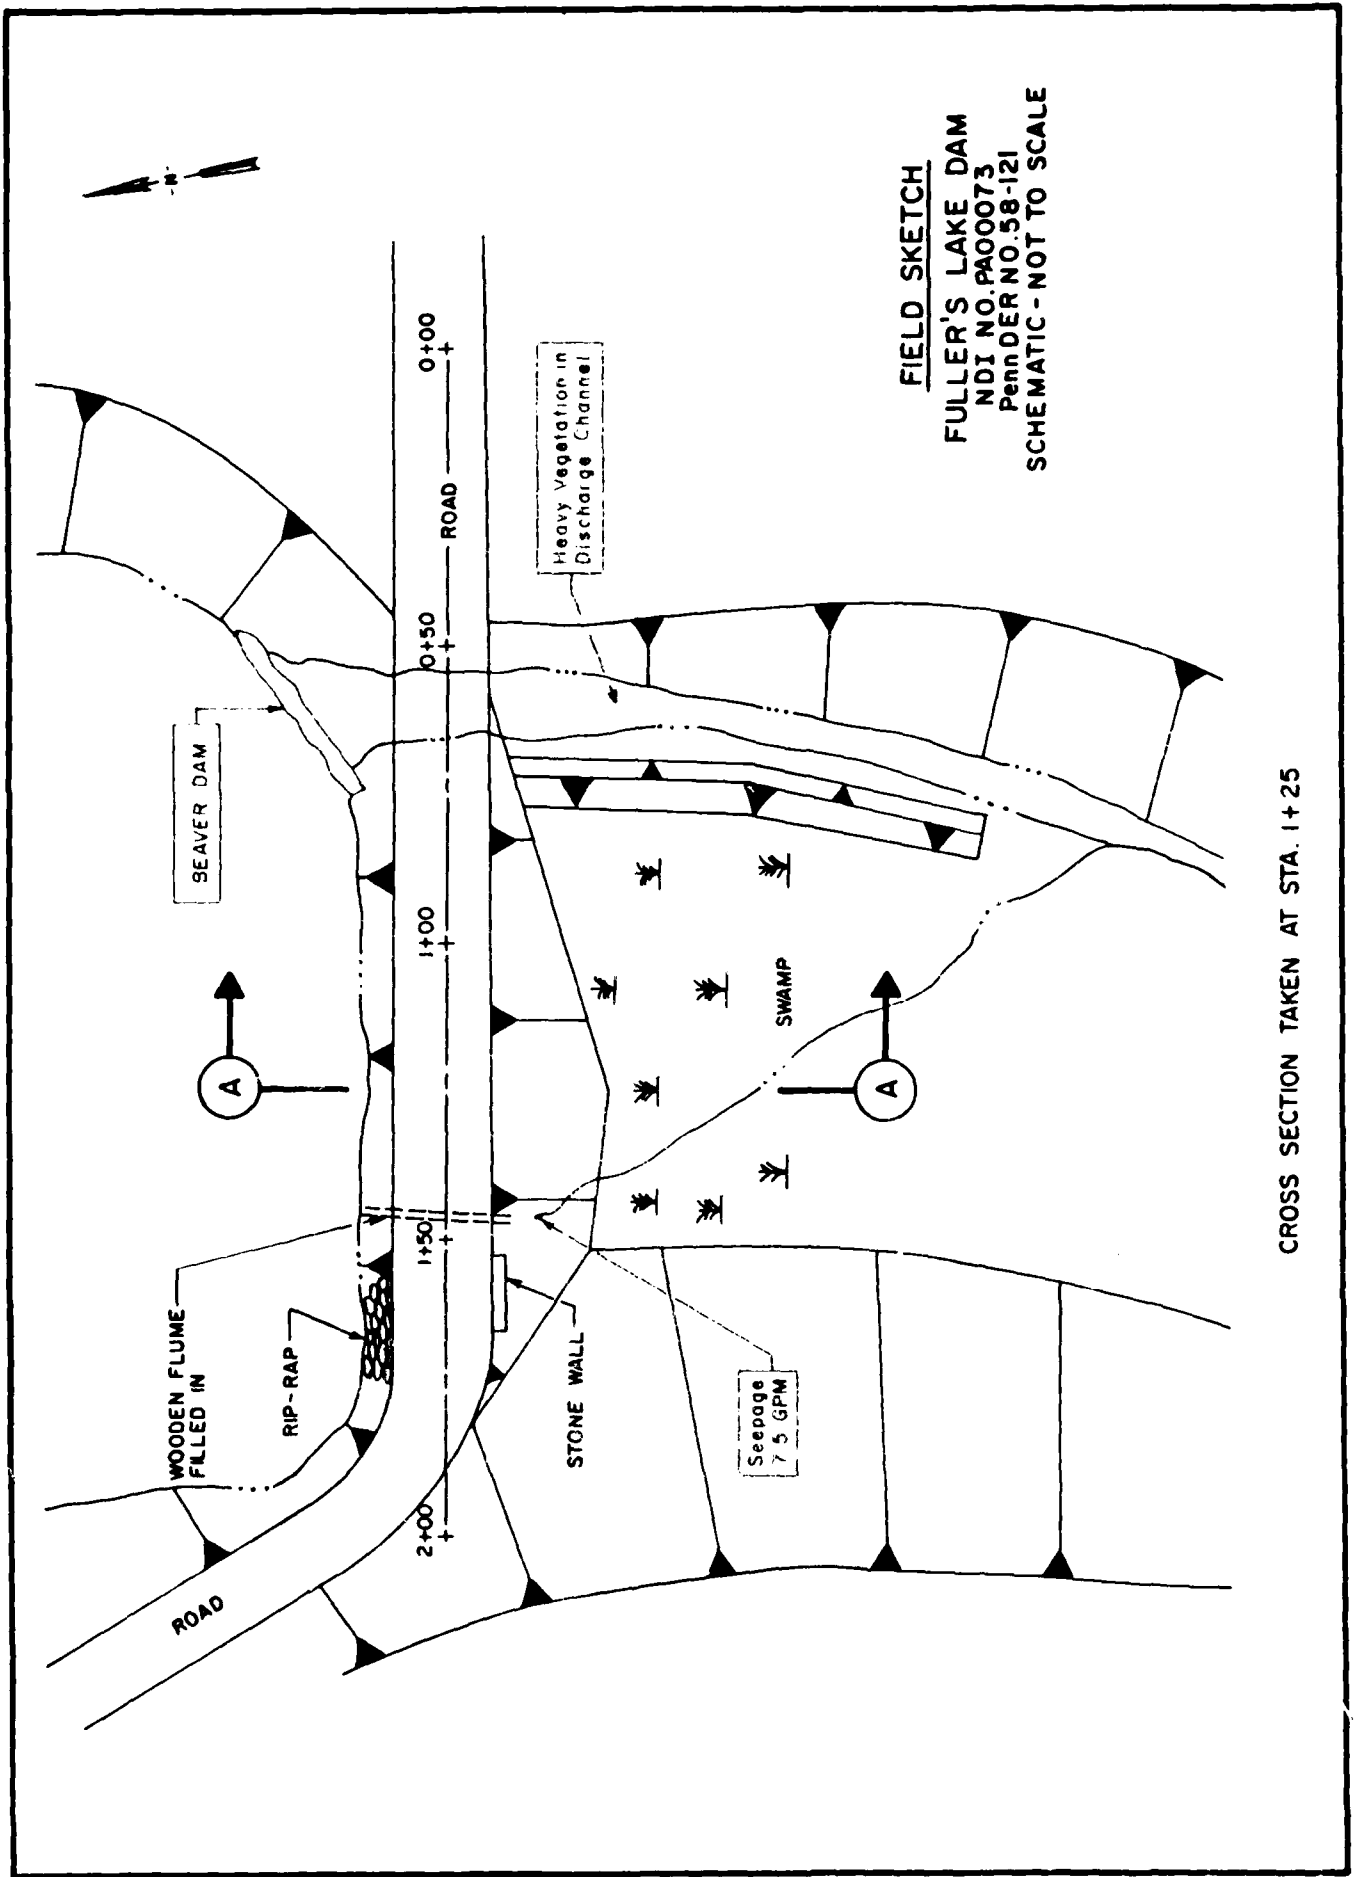
FIELD SKETCH

- b. Dam - Clear seepage was observed exiting the downstream slope at a rate of approximately 7.5 g.p.m. The vegetation and the erosion channel away from the seep indicated that the seepage has been occurring for a long period of time. The seep is located 8 feet vertically below the crest of the dam, at station 1+40 (see Field Sketch in Appendix A).
